Debris/Ice/TPS Assessment And Integrated Photographic Analysis For Shuttle Mission STS-49

July 1992

Gregory N. Katnik
NASA/Kennedy Space Center

OV-105 Endeavour (1st flight), ET-43 (LWT 36), BI-050 SRBs

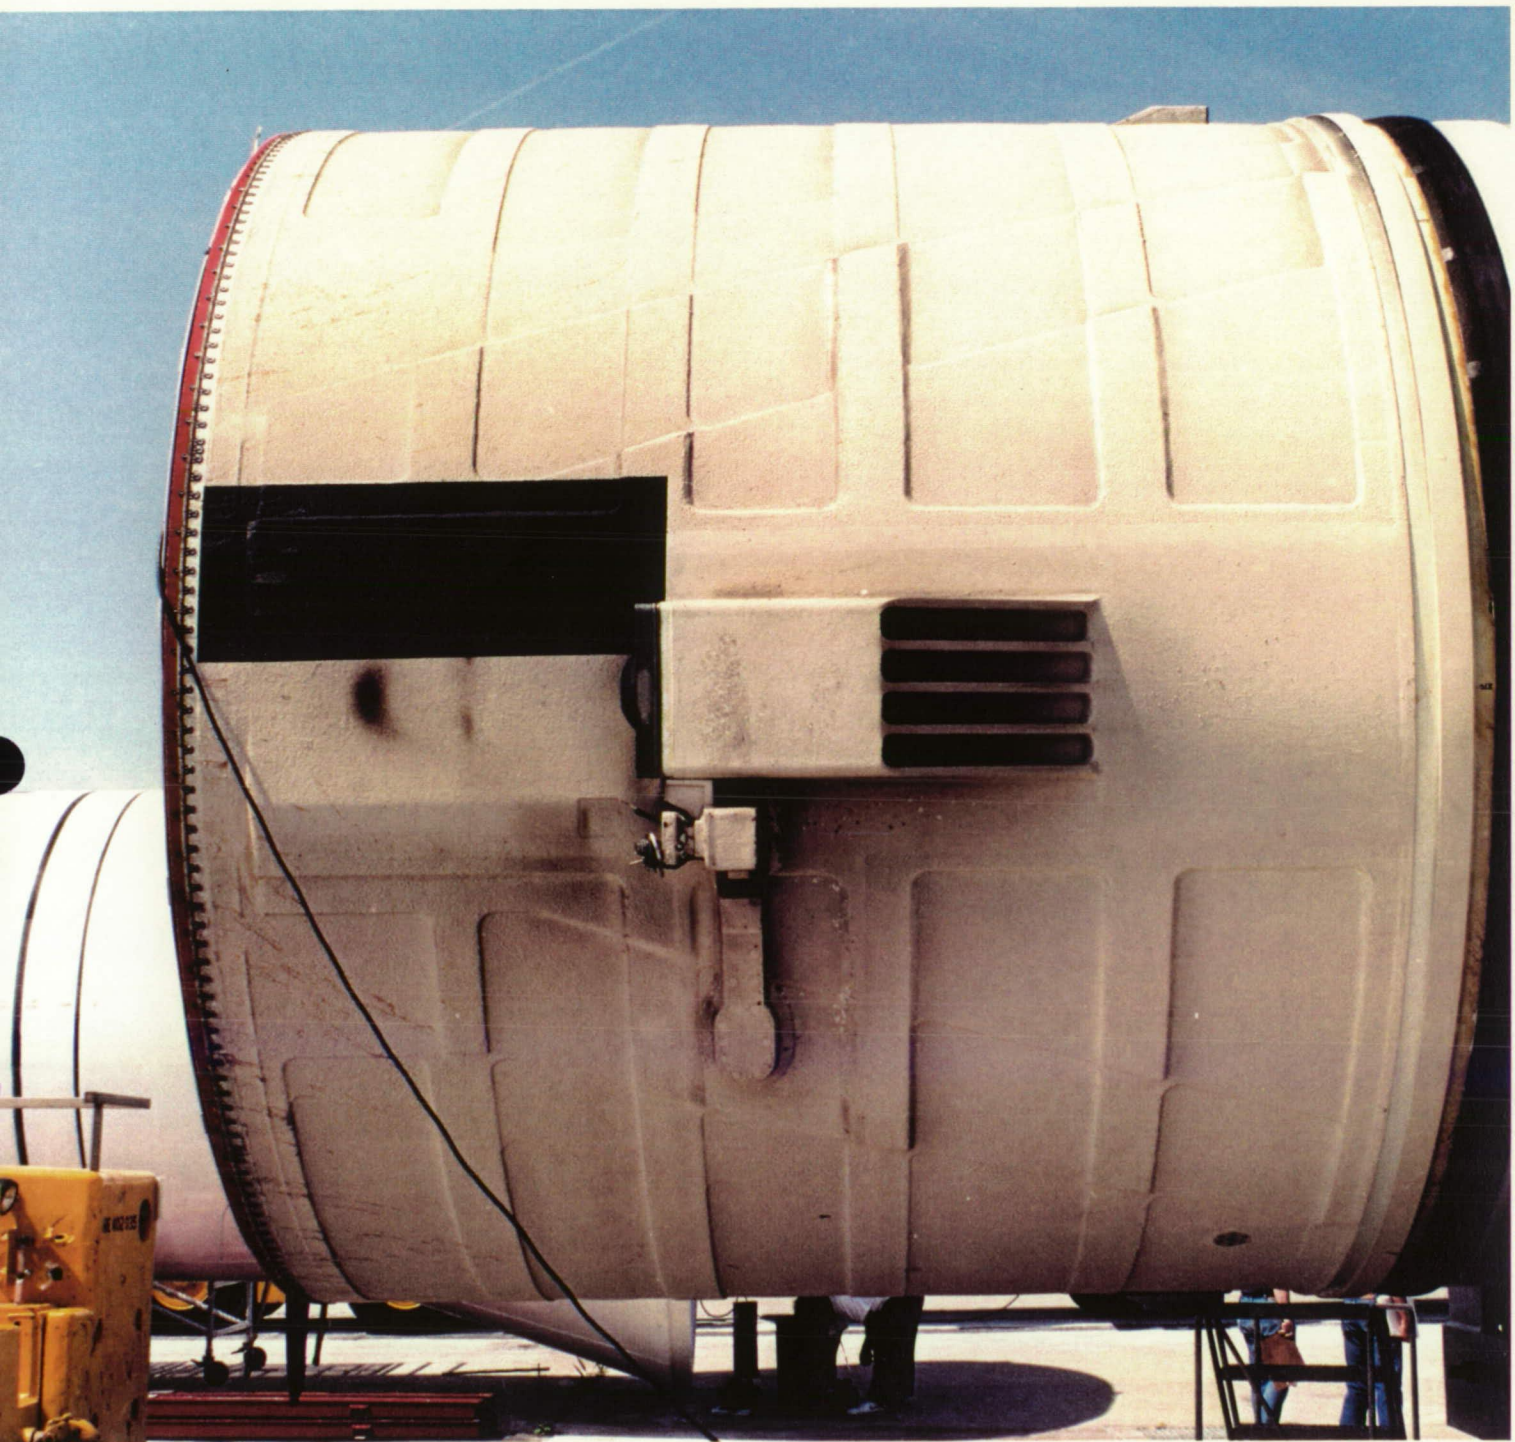
The RH forward skirt exhibited no debonds or missing TPS. Minor blistering of the Hypalon paint occurred in localized areas. Both RSS antenna phenolic plates were intact.

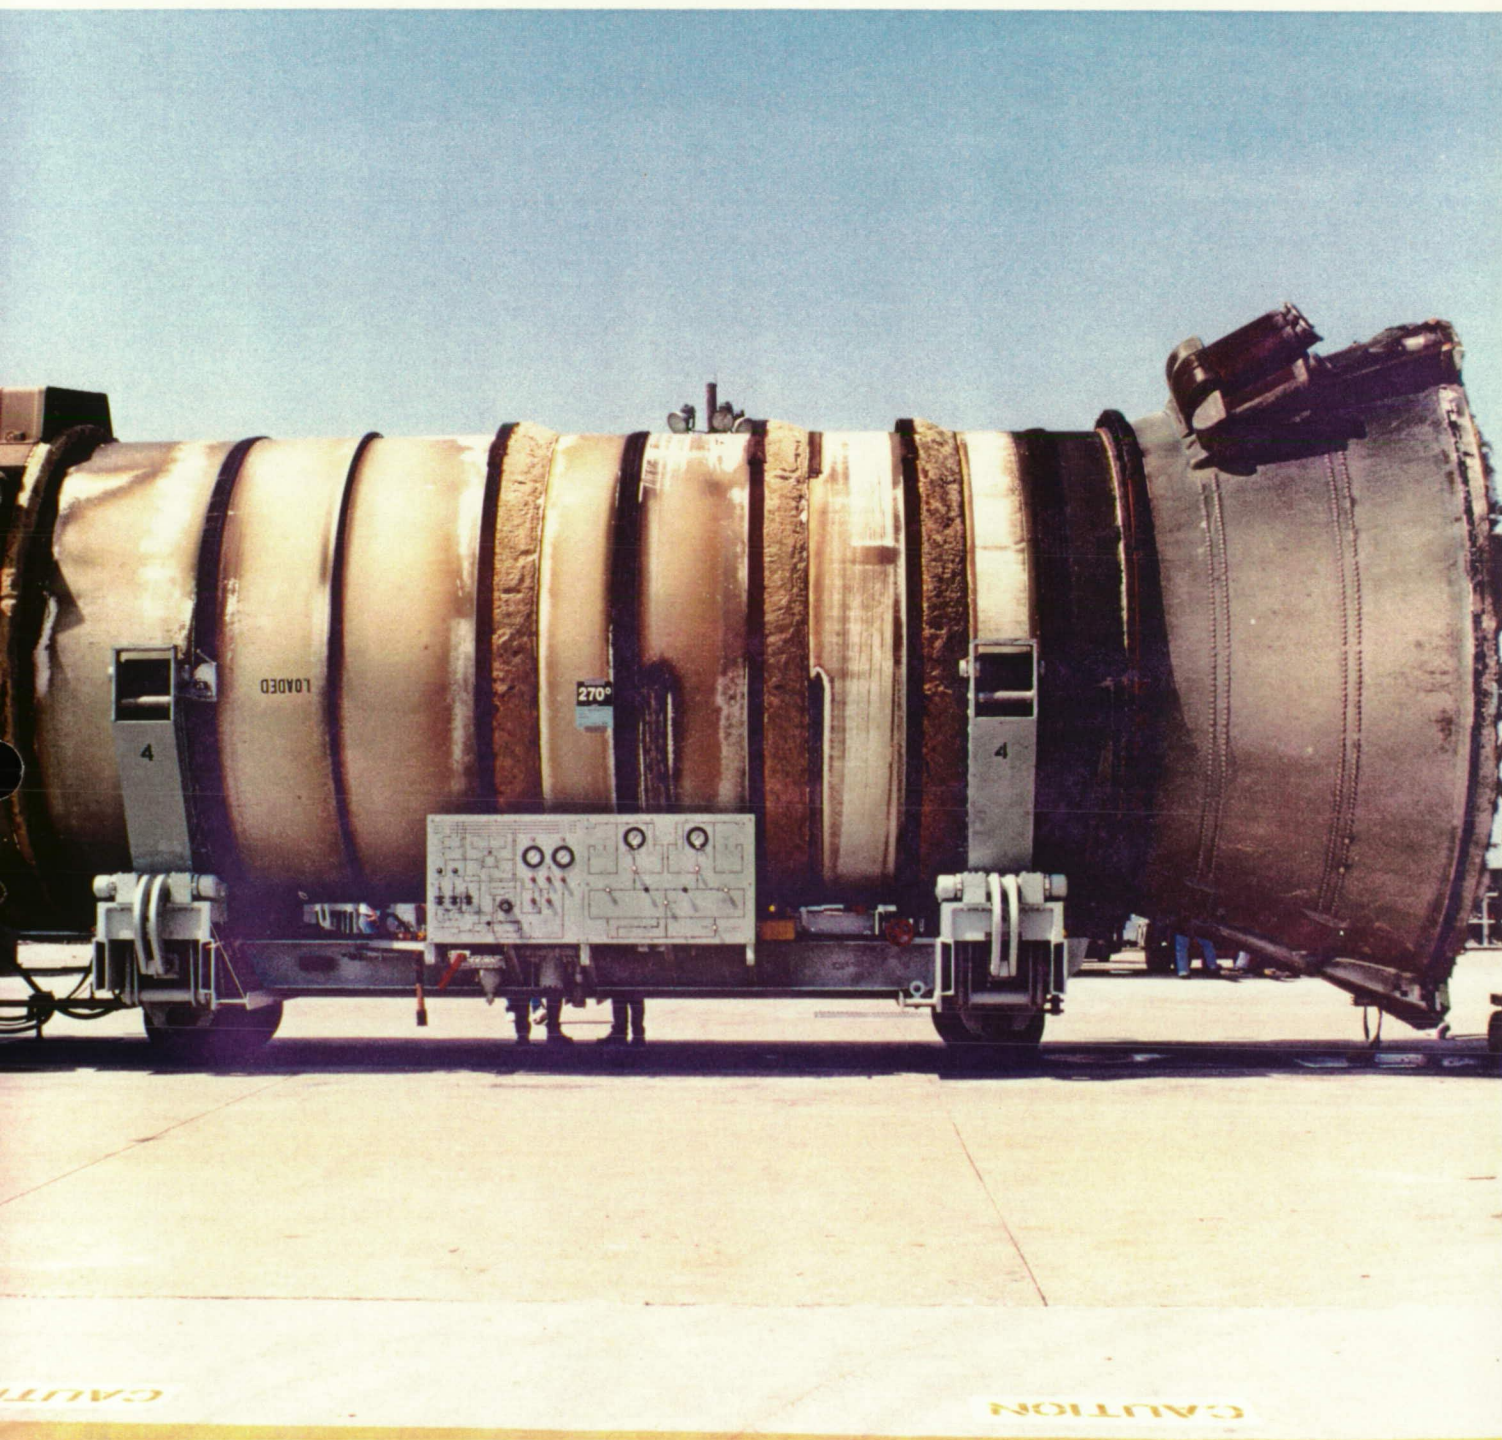
Post flight condition of the RH aft booster. The aft skirt acreage TPS was sooted but in good condition. The ET/SRB aft struts, ETA ring, and IEA appeared undamaged. All three aft booster stiffener rings sustained water impact damage.

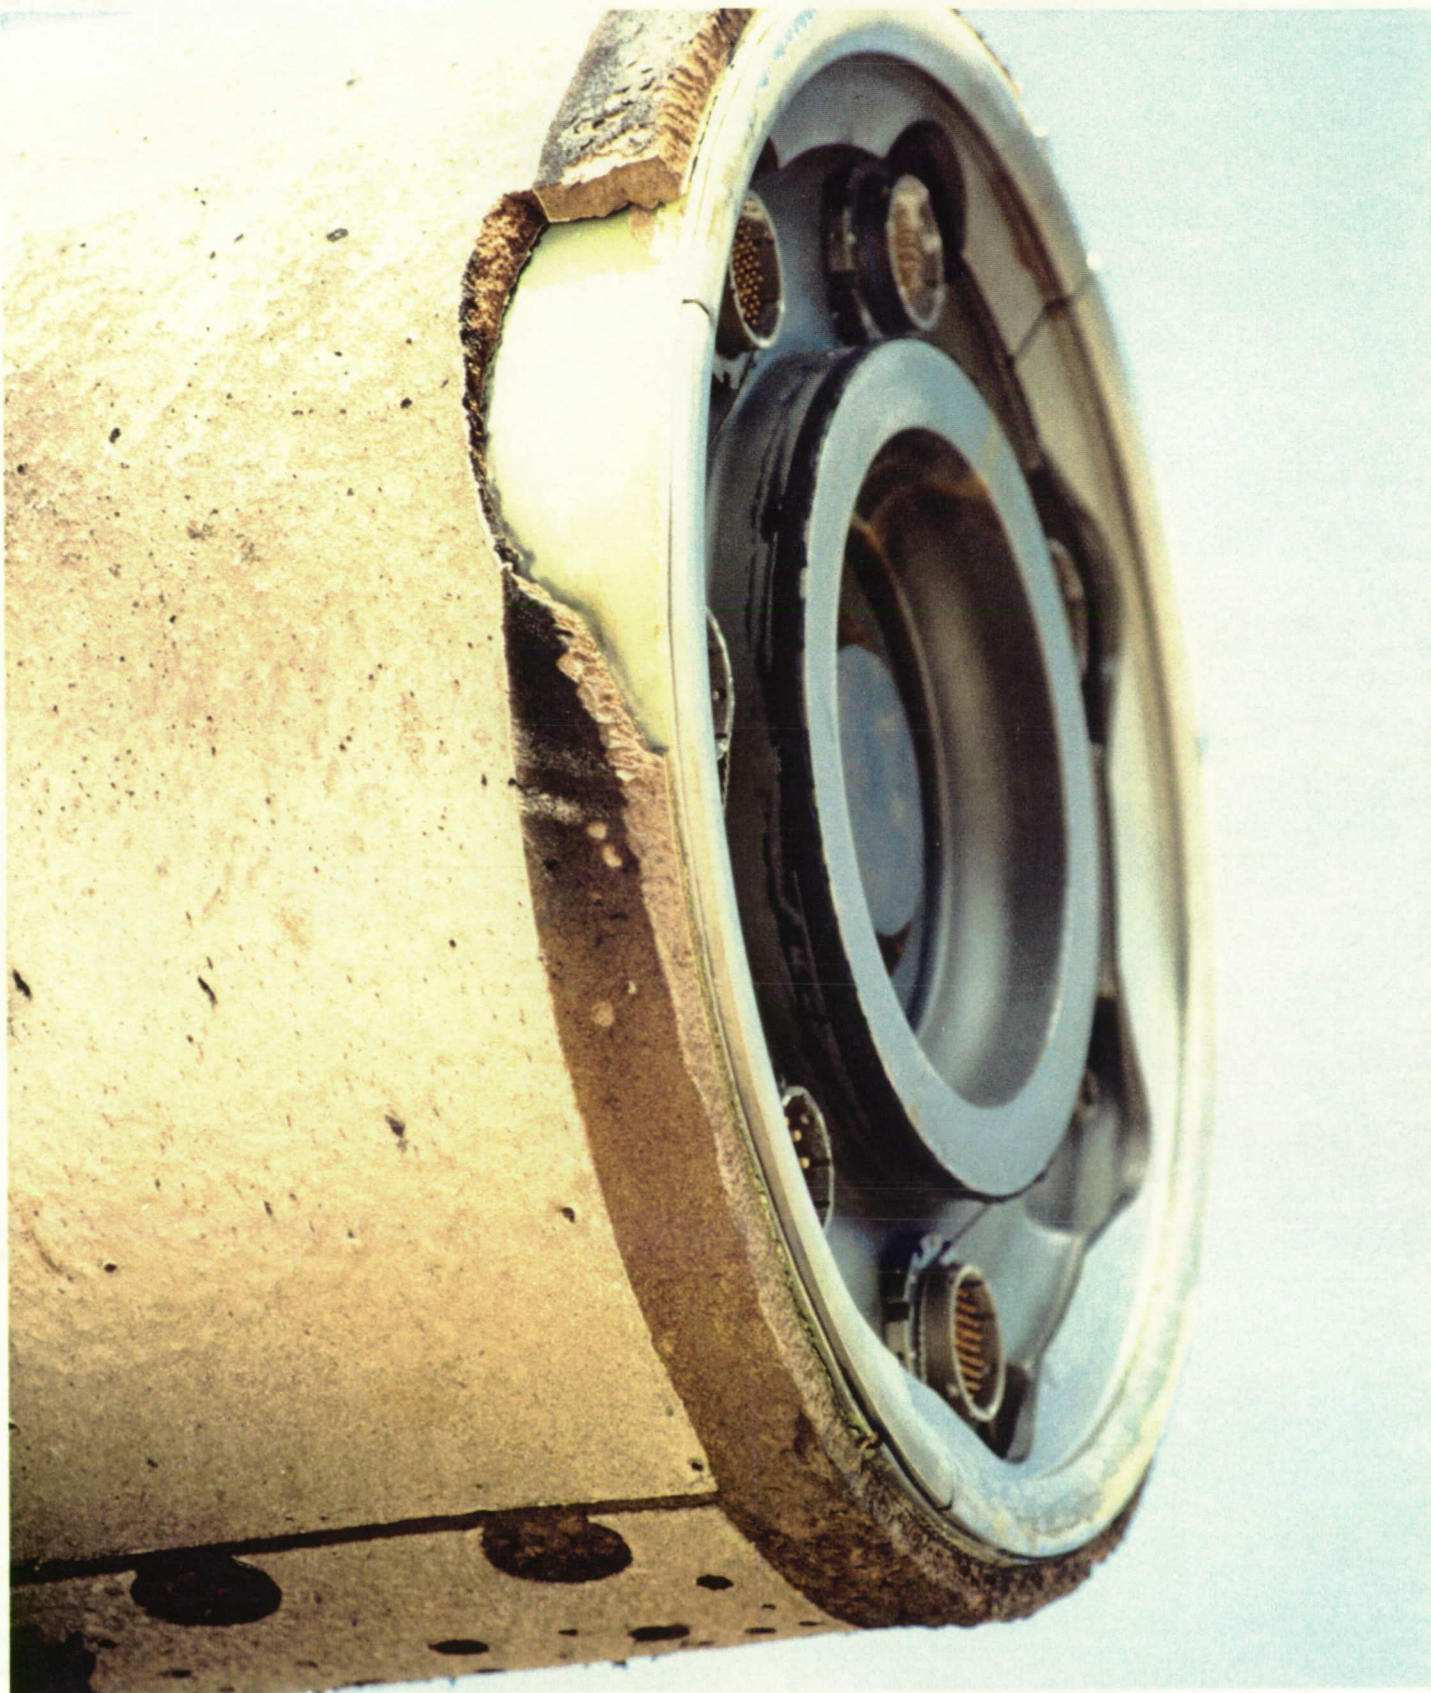
A 5"x1.5" area of TPS on the forward side of the upper strut fairing at the separation plane was missing but the substrate was not charred. The loss of TPS may have occurred during strut separation.

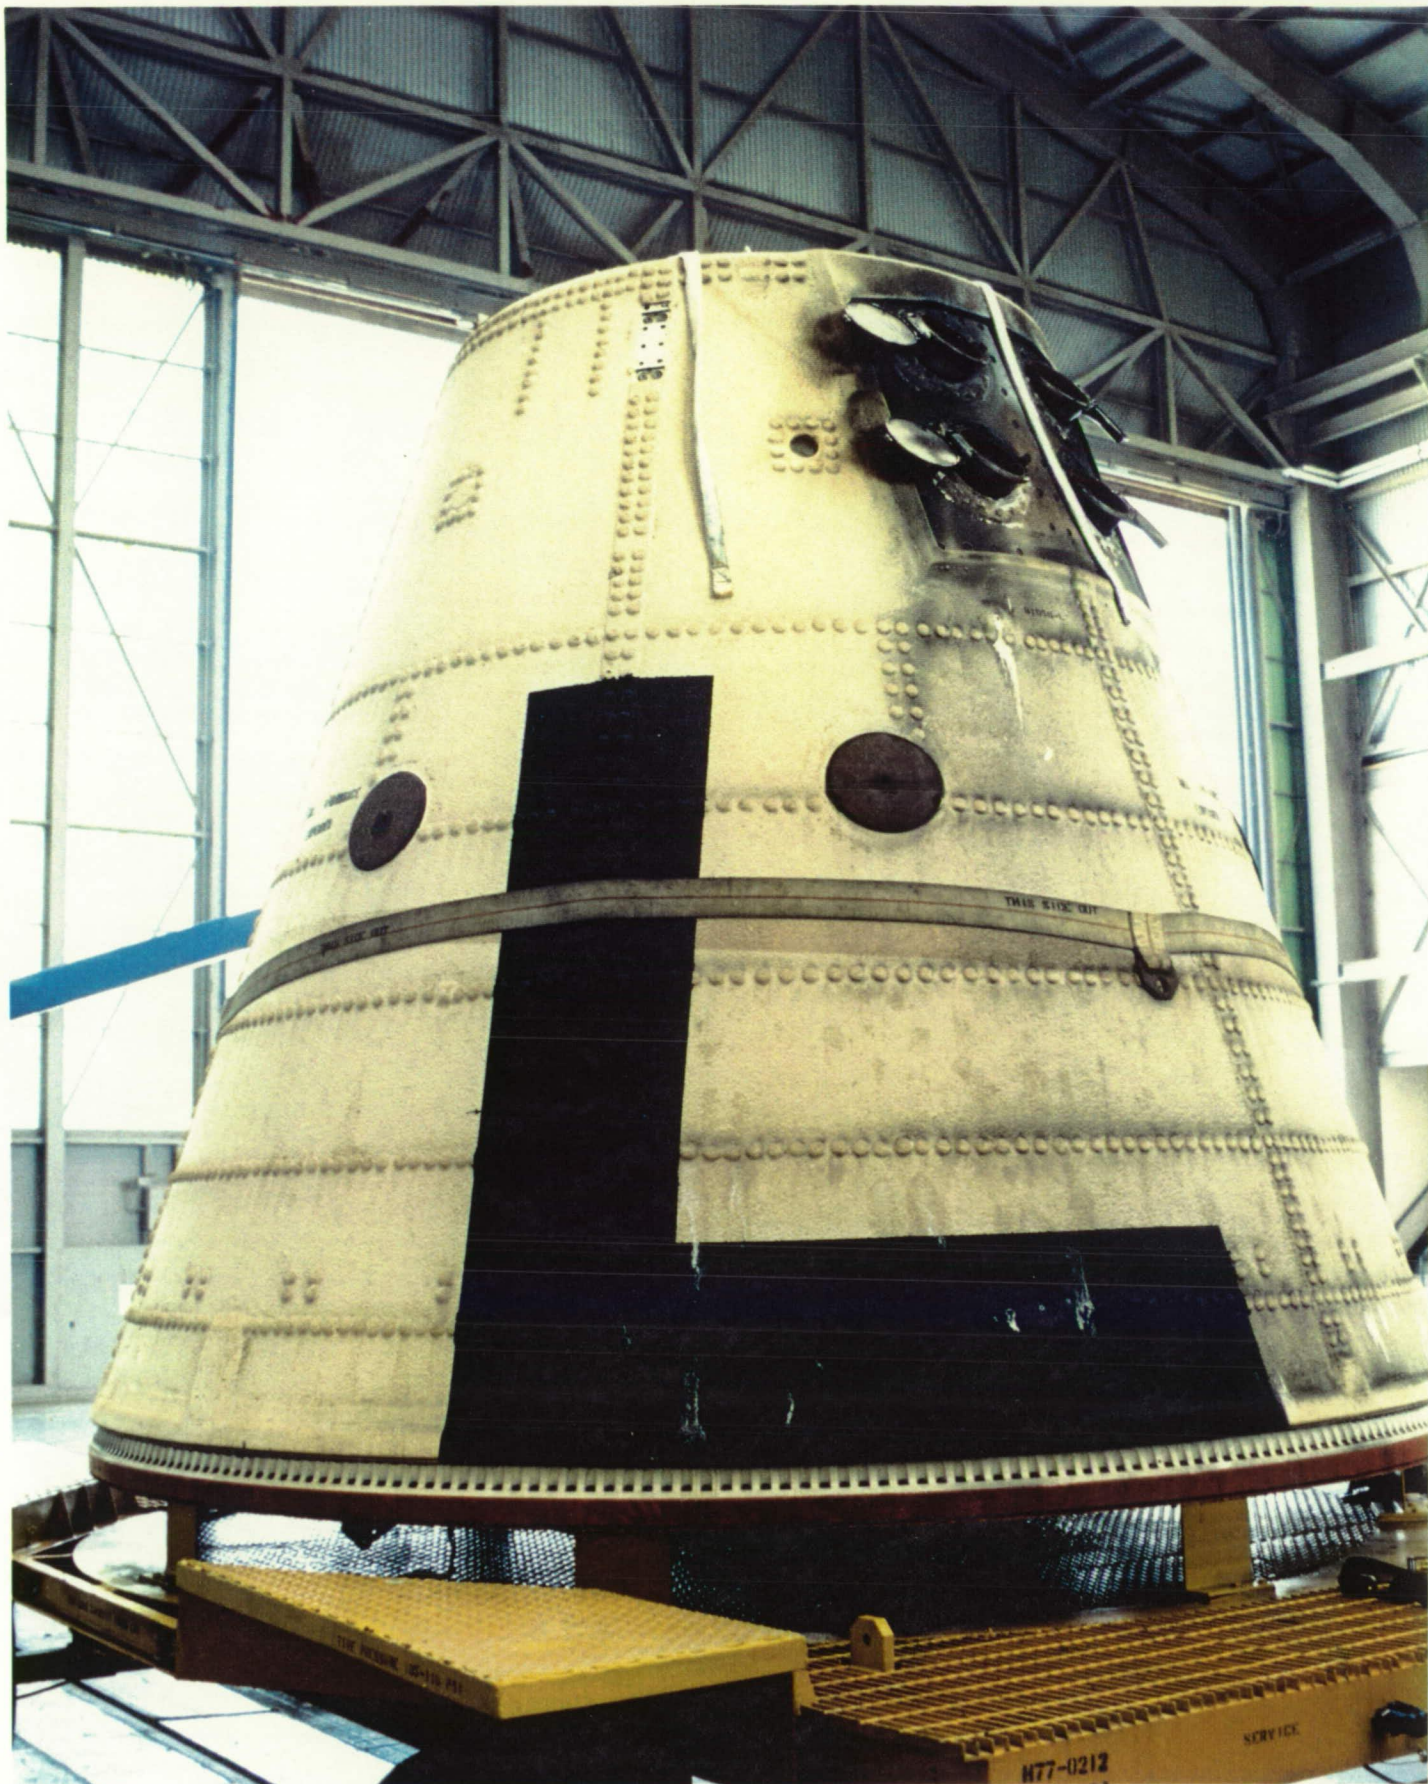
The LH frustum was missing no TPS but had 9 MSA-2 debonds over fasteners. There was minor localized blistering of the Hypalon paint. The BSM aero heat shield covers were locked in the fully opened position.

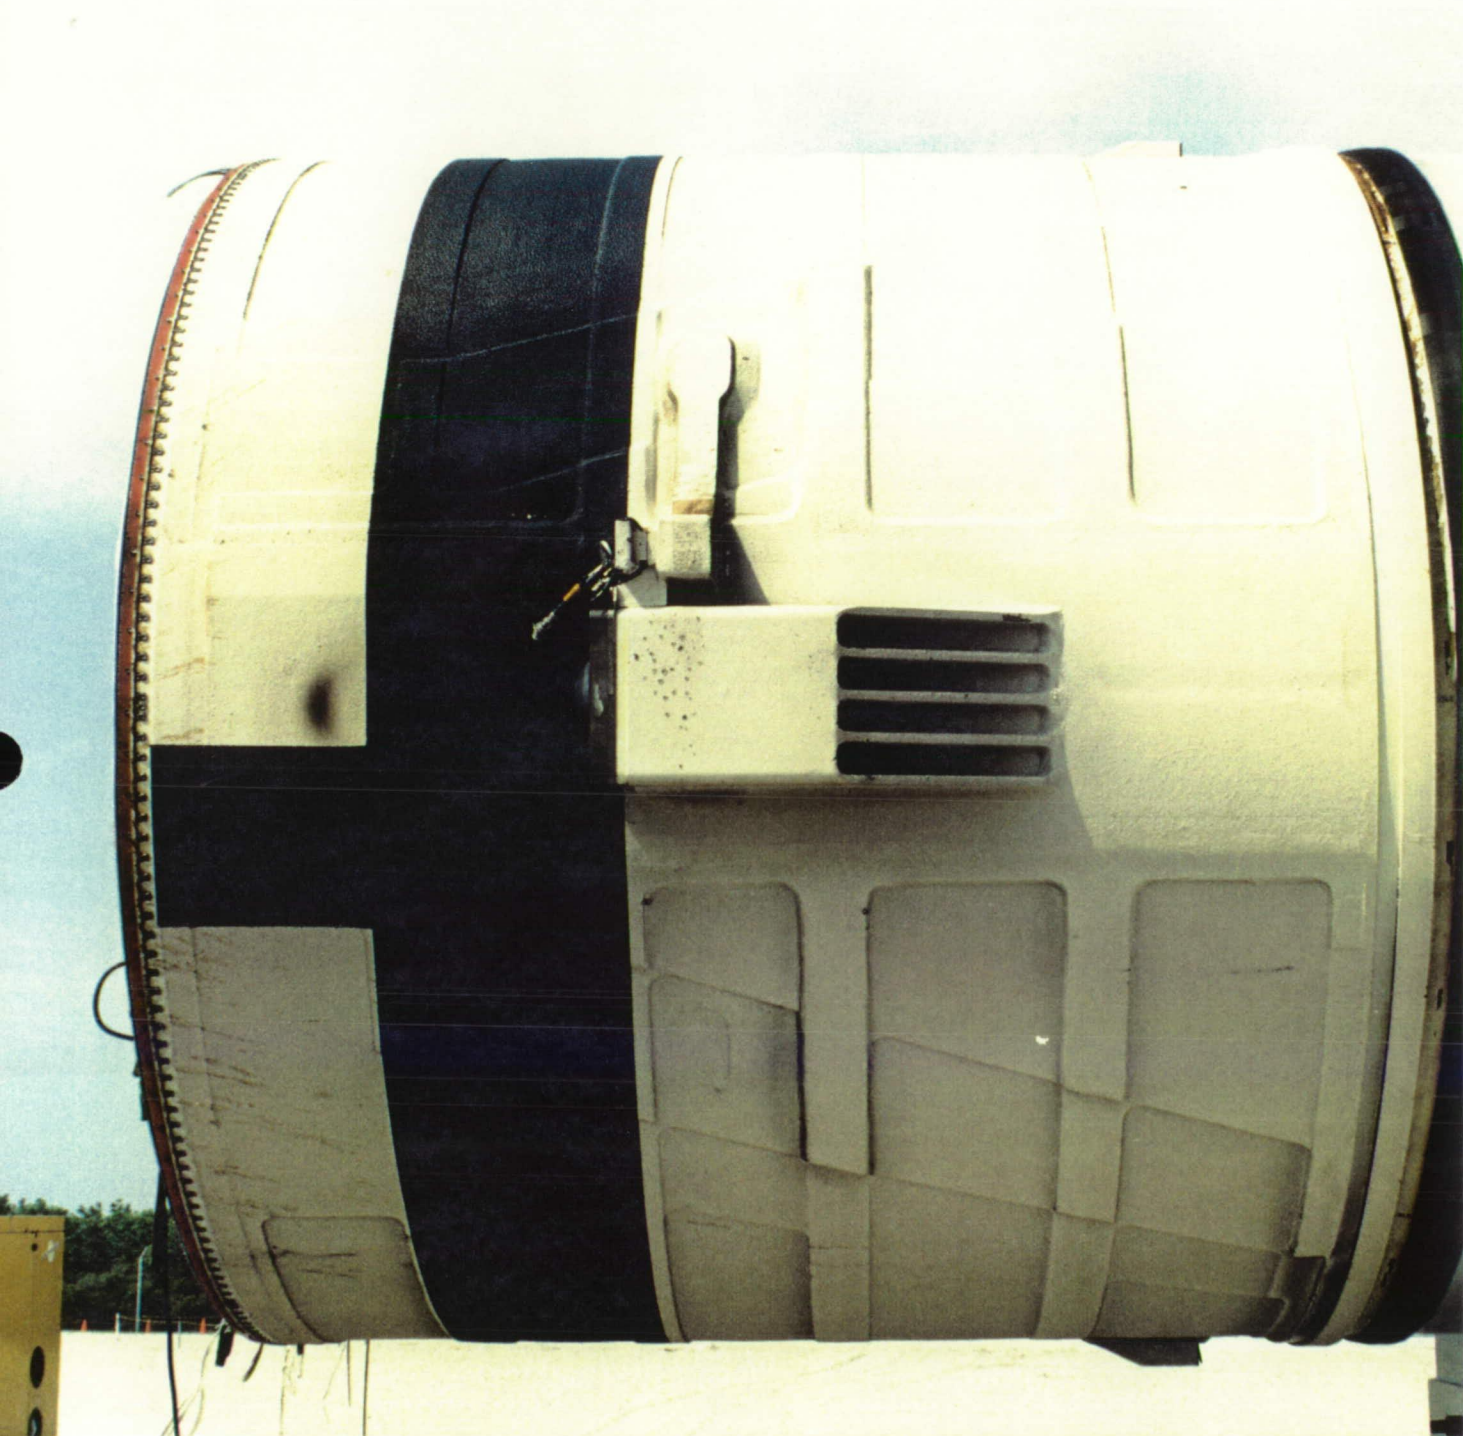
The LH forward skirt exhibited no MSA-2 debonds or missing TPS. The phenolic plates on both RSS antennae were intact, though the material on the +Z plate had delaminated.

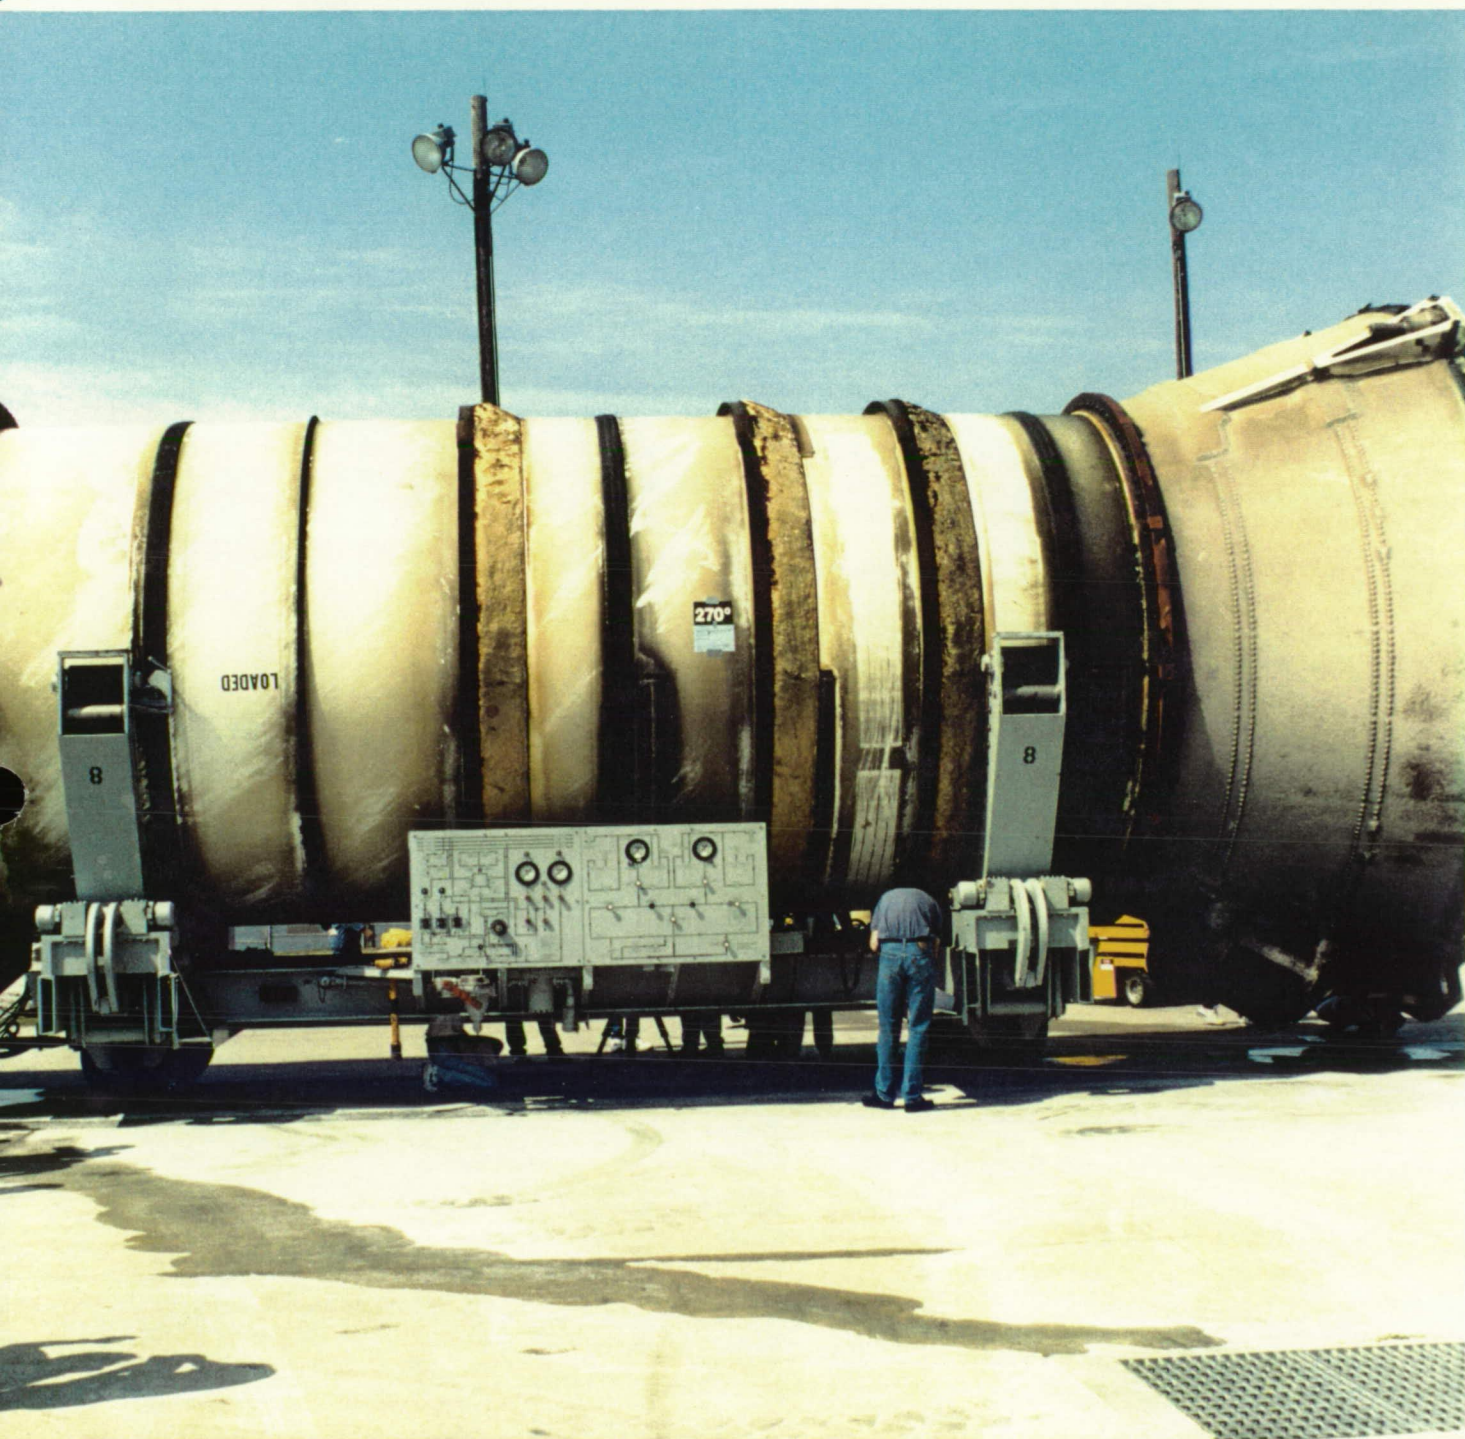
Post flight condition of the LH aft booster/aft skirt. The aft skirt acreage TPS was sooted but generally in good condition. The ET/SRB aft struts, IEA, and ETA ring appeared undamaged. All three aft booster stiffener rings sustained water impact damage.

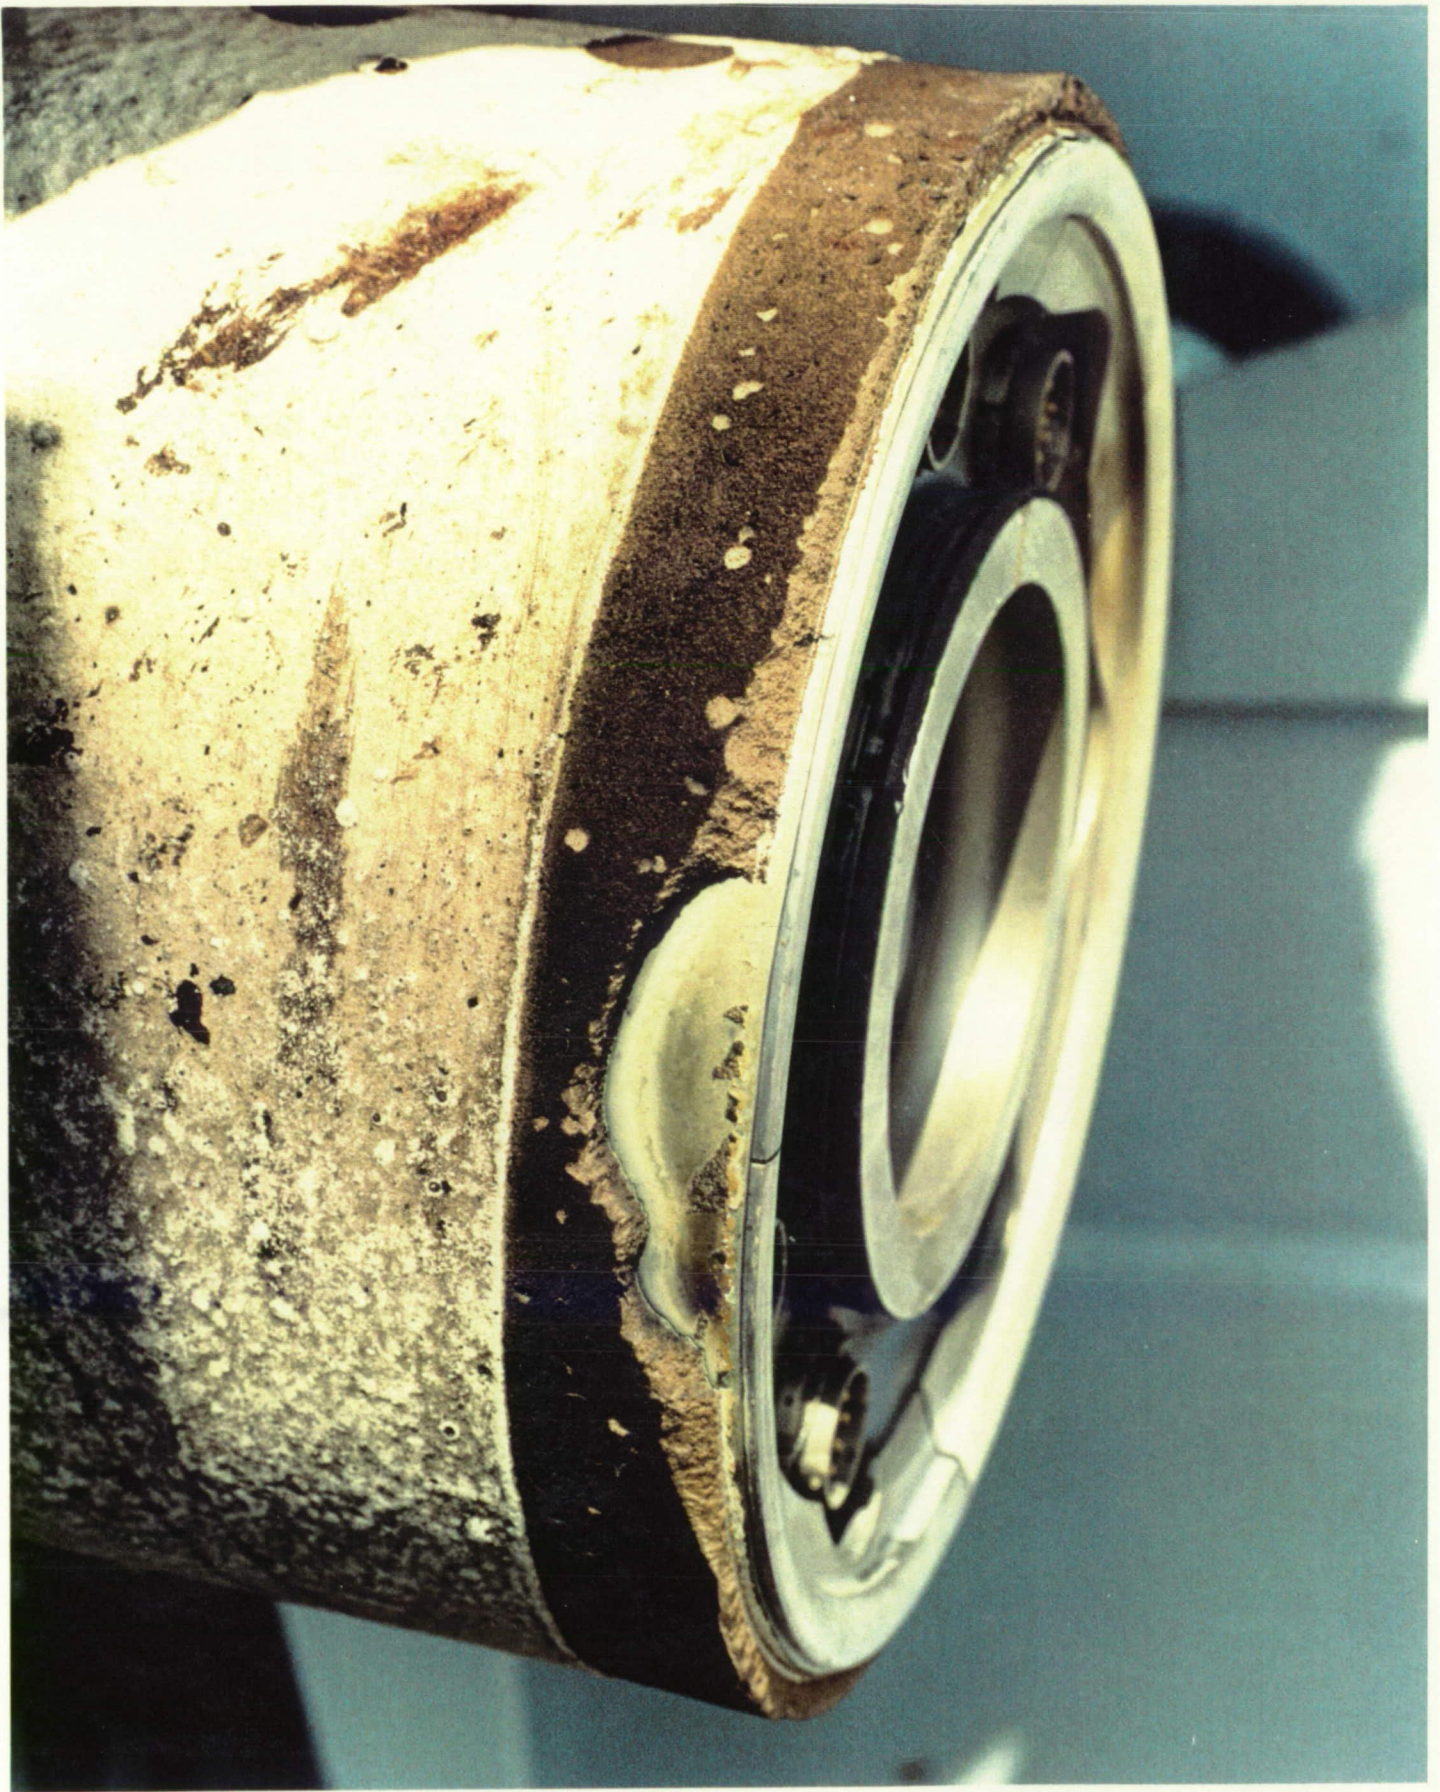
A 4.5"x3" area of TPS on the forward side of the upper strut fairing at the separation plane was missing and the substrate showed signs of heating. The loss of TPS may have occurred during strut separation.

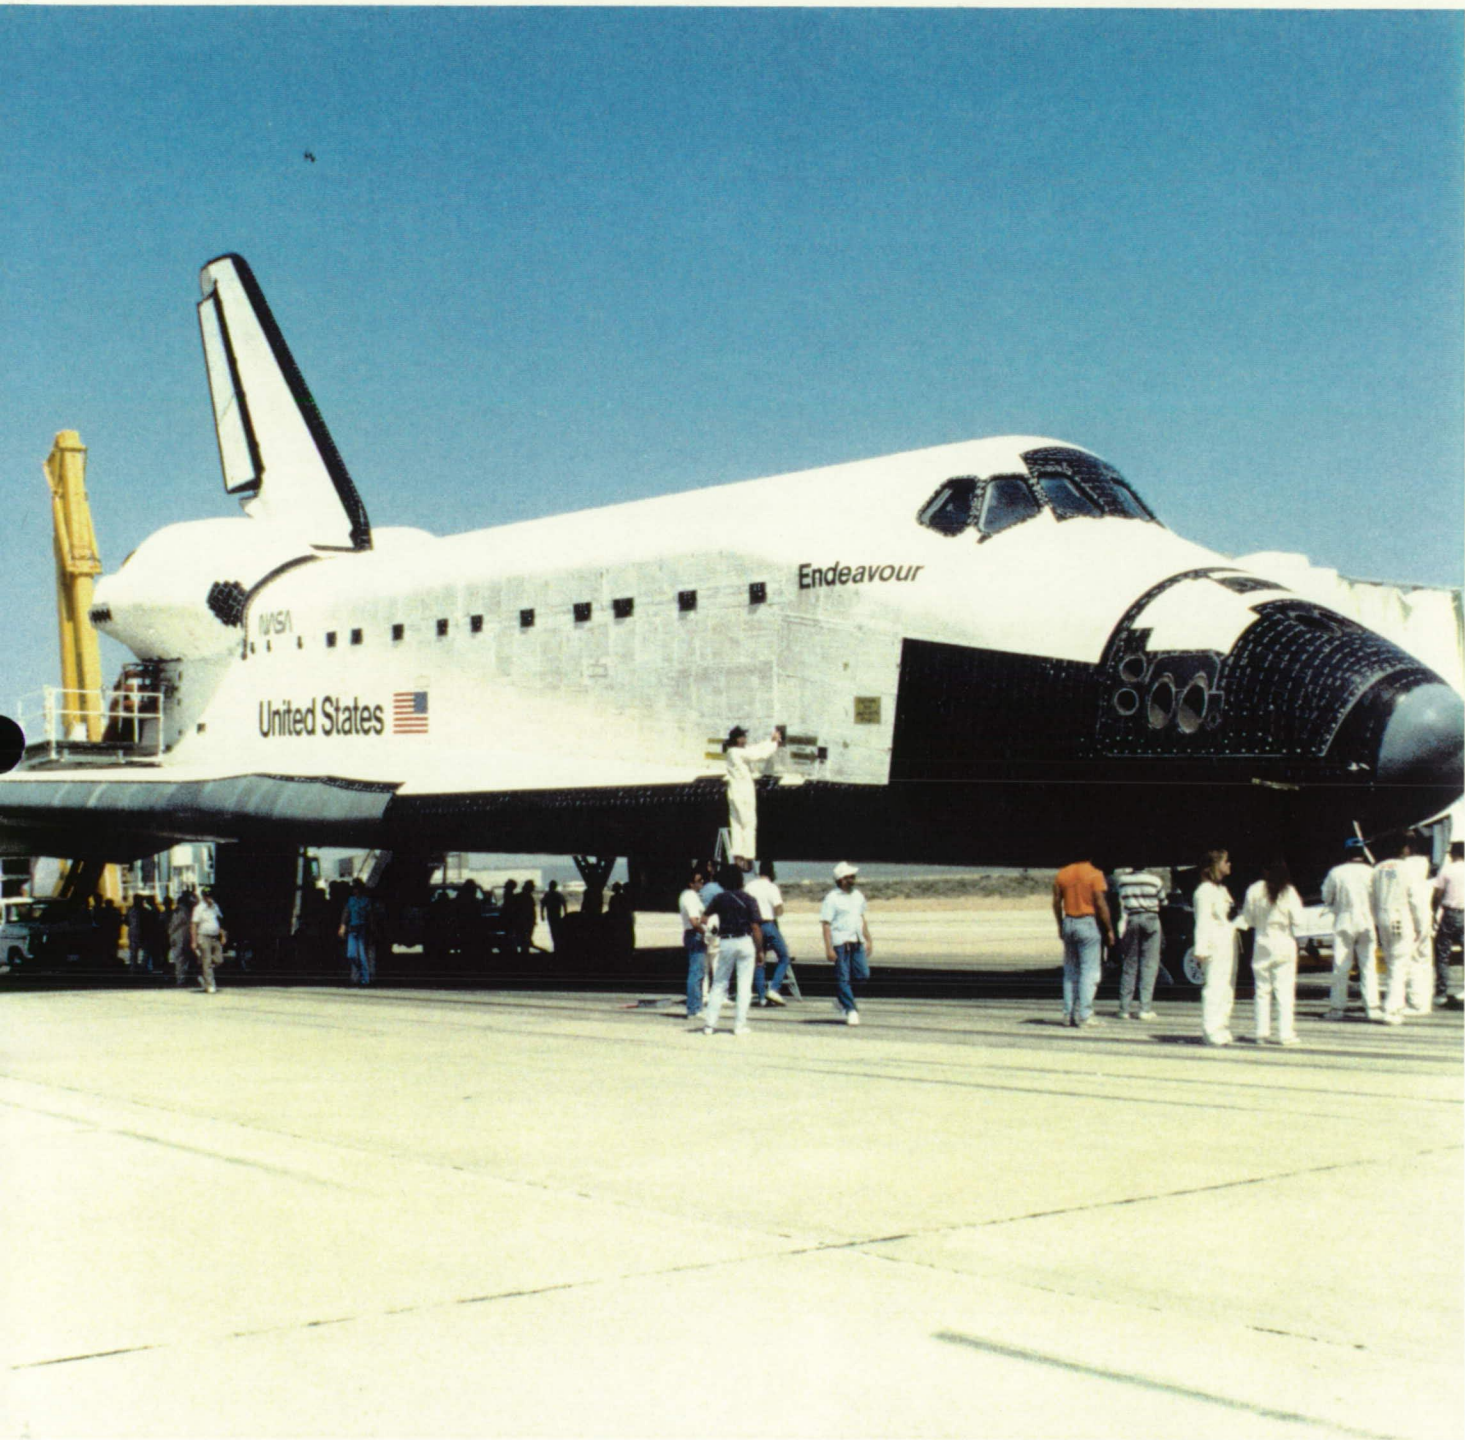
Overall view of Orbiter right side.
Note tile damage site just aft of the nose cap.

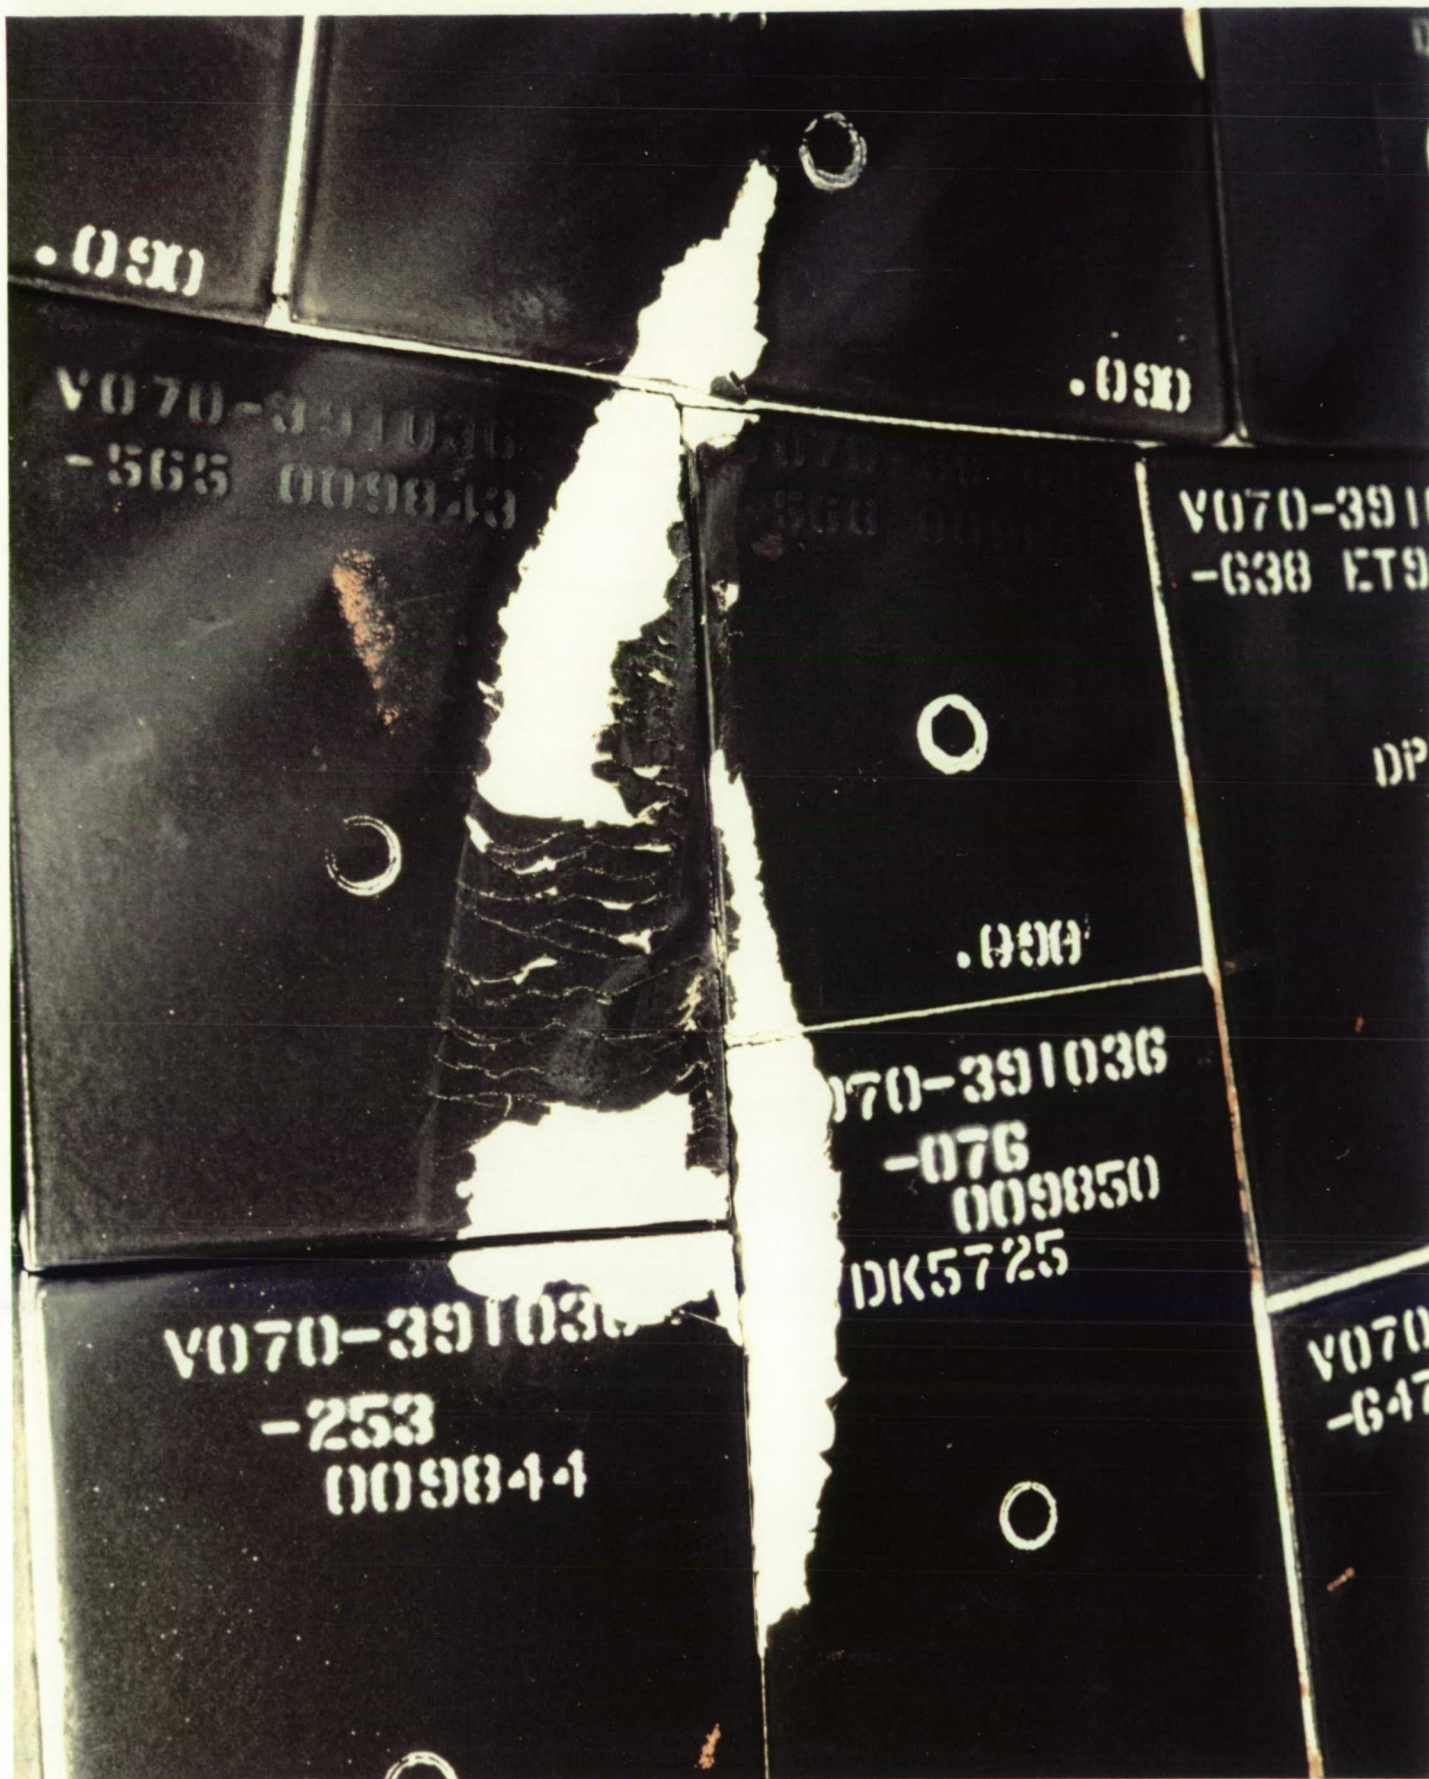
The most significant tile damage measured 9-5/8 x 2-5/8 x 1/4 inches and was located on the right side of the vehicle just aft of the nose cap RCC. The size and depth of this damage site is indicative of an impact by a low density material such as External Tank TPS foam. The following items were found on the runway underneath the RH ET umbilical door: a piece of a Jo-bolt, a spacer (washer), and a Torx head screw. Another Torx head screw was found on the runway underneath the LH ET umbilical door. This flight marked the first use of the Orbiter drag chute. According to JSC Deceleration System engineering, the drag chute functioned nominally. However, two tiles, one on the lower (-Z) edge of the drag chute opening and the other on the LH lower edge of the vertical stabilizer

Tile damage site on the right side of the Orbiter just aft of the nosecap RCC measured 9-5/8 x 2-5/8 x 1/4 inches. The size and depth is indicative of an impact by a low density material such as External Tank TPS foam.
